## **Stage 1 Road Safety Audit**

**Proposed Wind Farm at Inchamore Td, Coolea, Co Cork**

On behalf of Coillte CGA \ SSE Renewables Ltd

**April 2023**

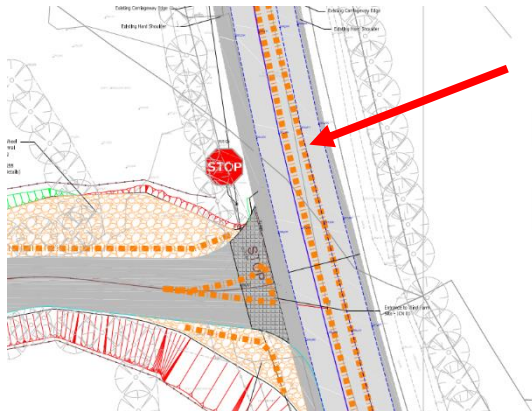
#### 3.2.1 National Road Climbing Lane

**Problem:** The proposals indicate barriers to be provided to close down the national road southbound offside lane, where the climbing lane exists. This area of the national road is up a steep gradient.

**Hazard:** Faster moving traffic may attempt to overtake slower moving vehicles that are particularly slow due to the road gradient, and cut back in just prior to the temporary barriers. Collisions with the barriers or side swipe collisions with the slow moving vehicle may result.

- Retain the dual lane set up for the full extent of the climbing lane.
- Adjust the refuge island within the mouth of the development junction such that right turning into the junction is near impossible for long vehicles.
- Ensure all drivers destined for the development are instructed to approach from the south only.

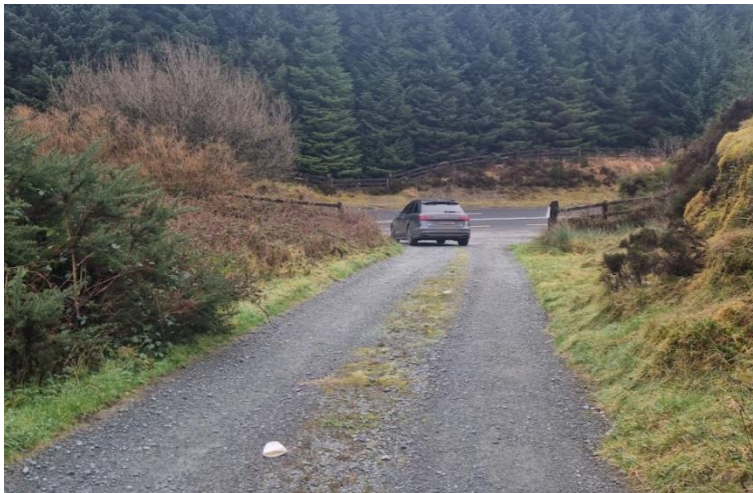
#### 3.3.1 Development Junction – Gradient

**Problem:** The development junction is to a steep downhill gradient. Users exiting the development may proceed towards the National Road at excessive speed and fail to stop for the junction.

**Hazard:** Overshoot incidents may result.

**Recommendation:** Provide suitable warning signage for drivers exiting the development together with advanced stop signage and also ensure suitable surface friction is provided and maintained on approach to the junction.

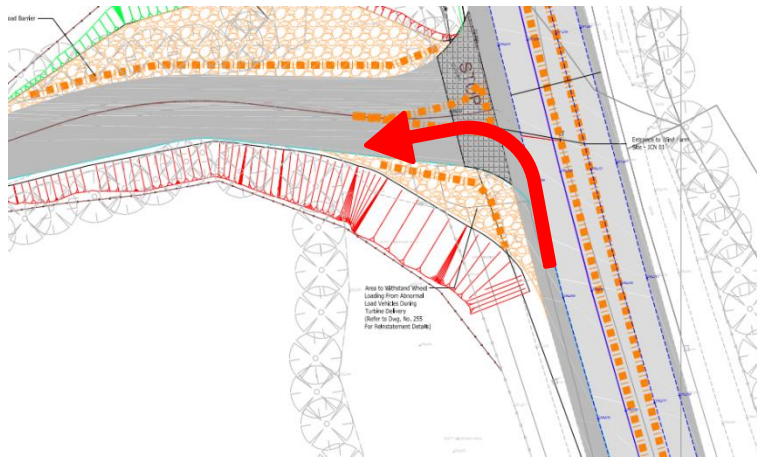
### 3.3.3 Vehicle Swept Paths

**Problem:** It is not clear from the drawings if delivery vehicles have sufficient space to enter the development left from the National Road.

**Hazard:** Users may slow/stop with the tail of the vehicle protruding into the National Road. Rear end shunts may result.

**Recommendation:** Undertake swept path analysis and adjust the paved area accordingly.

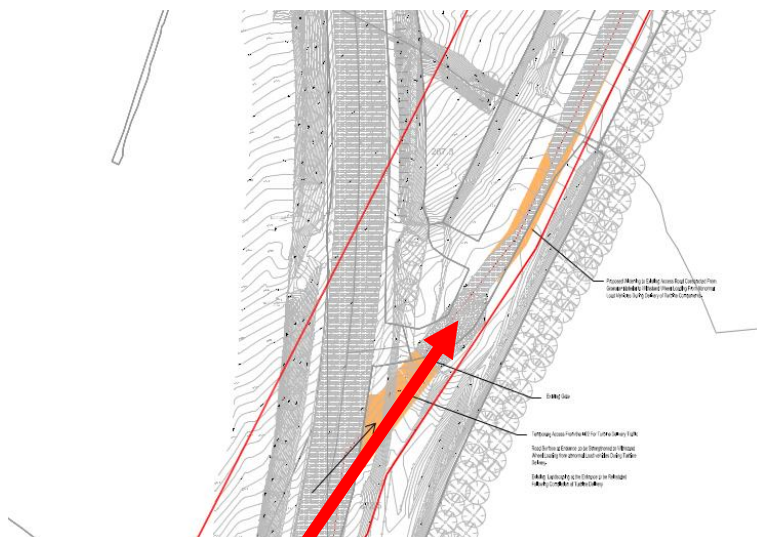
### 3.3.4 Turning Area

**Problem:** The audit team have been advised that vehicles departing the development will turn left from the development junction and undertake a turn at a location further to the north. The formation of the inbound junction for turning may appear as a continuation of the National Road during hours of darkness.

**Hazard:** Northbound National Road drivers may errantly divert from the mainline to enter this new junction. Impact with southbound National Road traffic may result.

**Recommendation:** Ensure this junction does not appear as a continuation of the National Road under any lighting conditions.
