## **Stage 1 Road Safety Audit**

**Proposed Wind Farm at Inchamore Td, Coolea, Co Cork**

On behalf of Coillte CGA \ SSE Renewables Ltd

**April 2023**

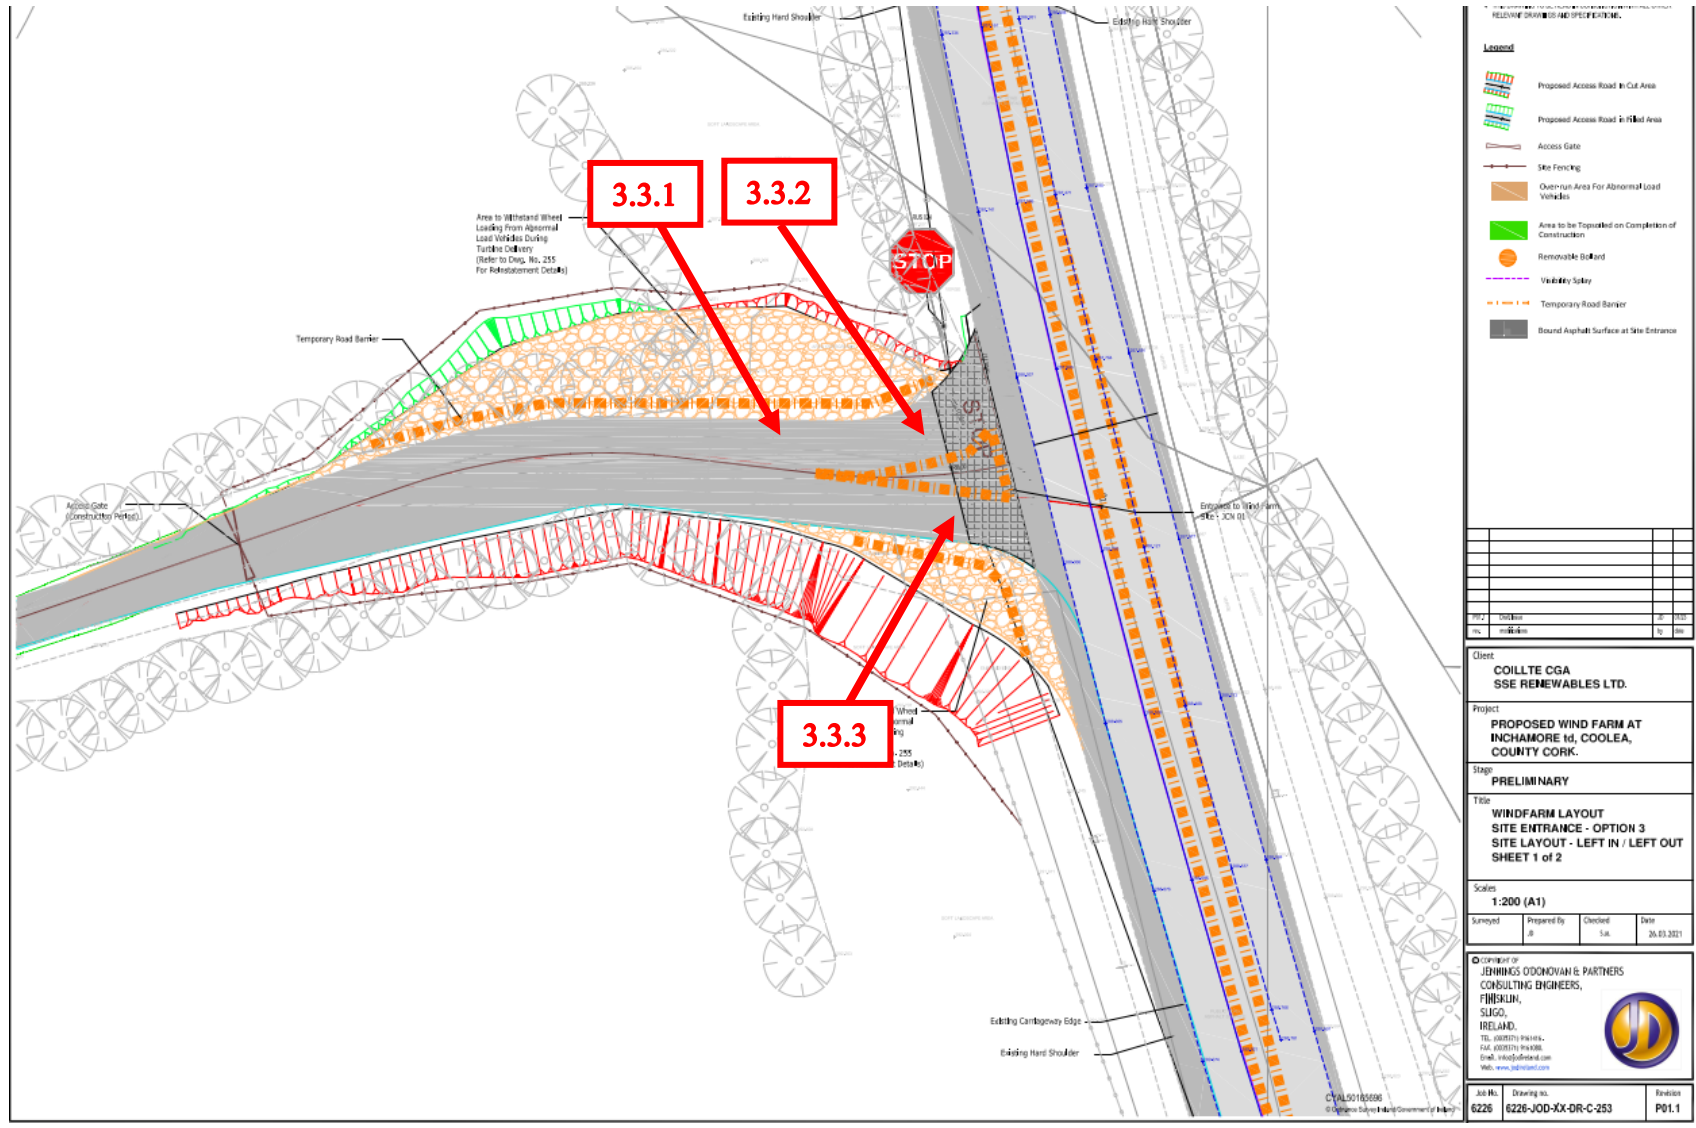
## **Appendix B      Problem Location Plan**

**Hazard:** Faster moving traffic may attempt to overtake slower moving vehicles that are particularly slow due to the road gradient, and cut back in just prior to the temporary barriers. Collisions with the barriers or side swipe collisions with the slow moving vehicle may result.

**Hazard:** The stationary vehicle may be subject to rear end shunts from through traffic.

**Problem:** The development junction is to a steep downhill gradient. Users exiting the development may proceed towards the National Road at excessive speed and fail to stop for the junction.

**Hazard:** Overshoot incidents may result.

**Hazard:** Loose material in the road may be thrown up into the windscreen of other vehicles, or strike cyclists.

**Hazard:** Users may slow/stop with the tail of the vehicle protruding into the National Road. Rear end shunts may result.

**Hazard:** Northbound National Road drivers may errantly divert from the mainline to enter this new junction. Impact with southbound National Road traffic may result.

**Recommendation:** Provide suitable signage prohibiting right turning into the development junction. Additionally, provide signage guiding development traffic to a suitable turning location further to the east.

**Recommendation:** Provide suitable warning signage for drivers exiting the development together with advanced stop signage and also ensure suitable surface friction is provided and maintained on approach to the junction.

**Recommendation:** Provide a bound surface to the access road.

**Recommendation:** Undertake swept path analysis and adjust the paved area accordingly.

**Recommendation:** Ensure this junction does not appear as a continuation of the National Road under any lighting conditions.
